DEPARTMENT OF TRANSPORTATION

Quality Assurance and Source Inspection

Contract #: 04-0120F4Cty: SF/ALA Rte: 80 PM: 13.2/13.9File #: 69.28**WELDING INSPECTION REPORT****Resident Engineer:**Pursell, Gary**Address:** 333 Burma Road**City:** Oakland, CA 94607**Report No:** WIR-016067**Date Inspected:** 06-Aug-2010**Project Name:** SAS Superstructure**OSM Arrival Time:** 700**Prime Contractor:** American Bridge/Fluor Enterprises, a JV**OSM Departure Time:** 1900**Contractor:** Zhenhua Port Machinery Company, Ltd (ZPMC), Changxing Island **Location:** Shanghai, China

| Bridge No: | 34-0006 | Component: | OBG Trial Assembly | |

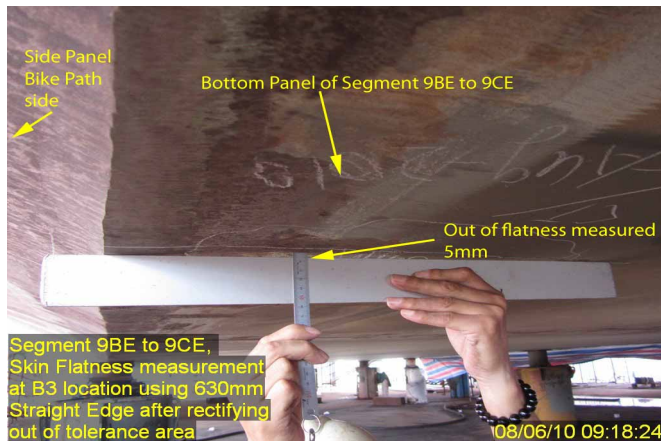
The skin flatness was measured on South side (Bike Path side at B3 location) from the weld connecting Bottom Panel to Side Panel using Straight Edges of 630 mm of length and observed dimension in general compliance.
